# Manhole Inspection Summary

Manhole # S25GG1003MH

Insp Date: **1/23/07 2:02 PM**

**Location** Address: **4106 EVANS CHAPEL RD**

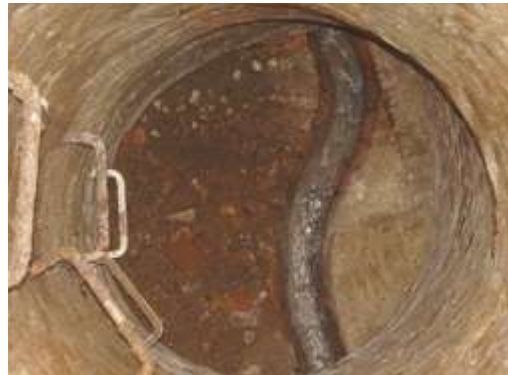
Top View

Evidence of surcharge - Bench debris.

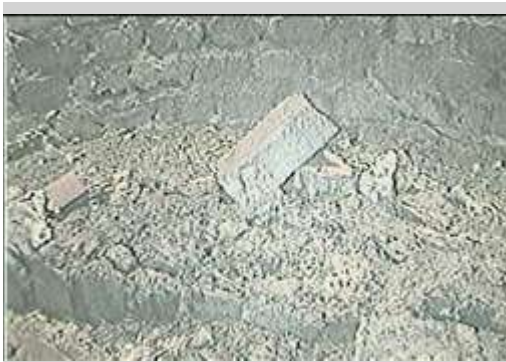
Defect

Barrel deterioration and infiltration. Bench debris.

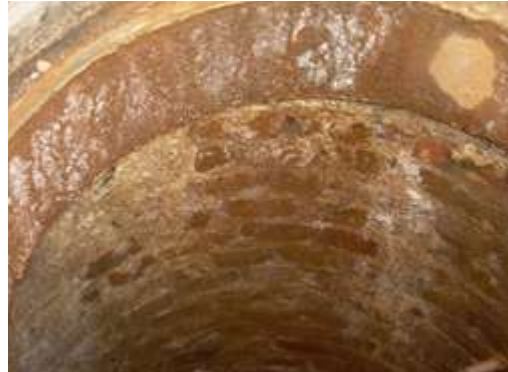
Defect

Frame leaks. Adjustment infiltration.

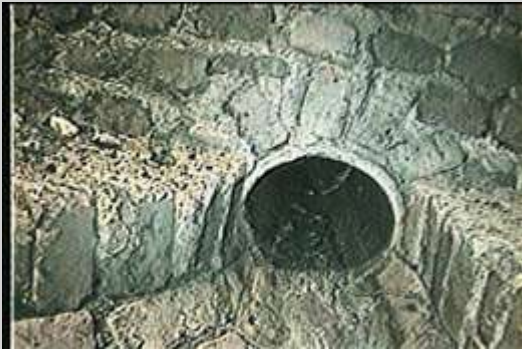
Pipe Out @ 12 O'Clock

Barrel deterioration and infiltration. Channel deterioration.

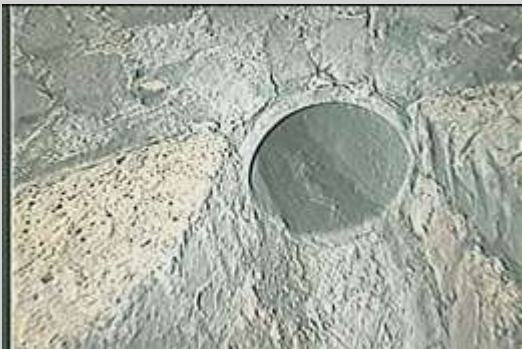
Pipe In @ 6 O'Clock

Infiltration: **Evidence** Pipe Seal Cond: **Cracked**
